**Flood Control Project Maintenance
Levee Inspections**
LMA District Cover Sheet
Spring 2018 Levee Inspection Results

Reclamation District No. 0787 Fair

Levee Inspection Report By Mile - Spring 2018

Waterway	Bank	Unit Miles	Inspection Start/End	Inspector
Unit No. 01 Colusa Basin Drain	Left	4.45	03/16/2018 03/16/2018	Zach Jojoia

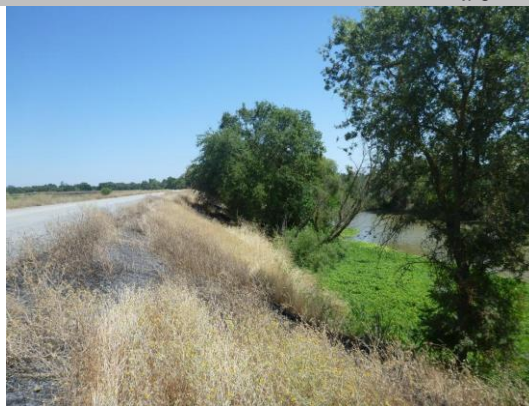
Photo 1 of 3 : LEVAL_SP_2018_182_1520.jpg

LM Start	0.73	Rating **	M	Issue No.	4
LM End	0.86	Issue Type +	Ma	Location *	
Category	Supplemental			GPS Latitude/Longitude	
				Start	End
Item	2017 Storm Damage			38.795769 °	38.796340 °
				-121.736798 °	-121.738956 °
DWR ID	DWR_RD0787_01_f_2017_4				
Comment Code					
Inspector Comment					
Levee Evaluation Comments					
Description:					
Site ID No:182					
Site Designation:RD 787-01					
Repair Type: Erosion					
Rating:Area of Concern					
Field Date:7/18/2017					
Notes: Sloughing from 2017 storms.

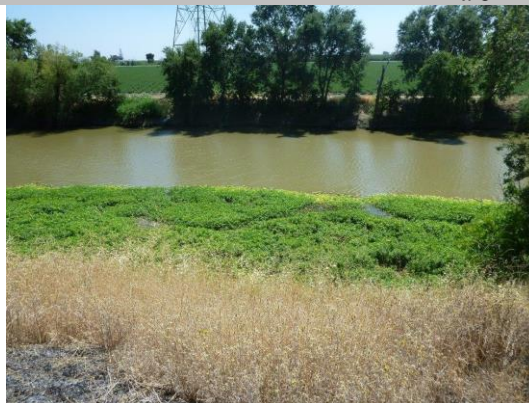
Photo 2 of 3 : LEVAL_SP_2018_182_1522.jpg

LM Start	0.73	Rating **	M	Issue No.	4 (cont)	
LM End	0.86	Issue Type +	Ma	Location *		
Category	Supplemental			GPS Latitude/Longitude		
				Start	End	
Item	2017 Storm Damage			38.795769 °	38.796340 °	
				-121.736798 °	-121.738956 °	
DWR ID	DWR_RD0787_01_f_2017_4					
Comment Code						
Inspector Comment						
Levee Evaluation Comments						
Description:						
Site ID No:182						
Site Designation:RD 787-01						
Repair Type: Erosion						
Rating:Area of Concern						
Field Date:7/18/2017						
Notes: Sloughing from 2017 storms.

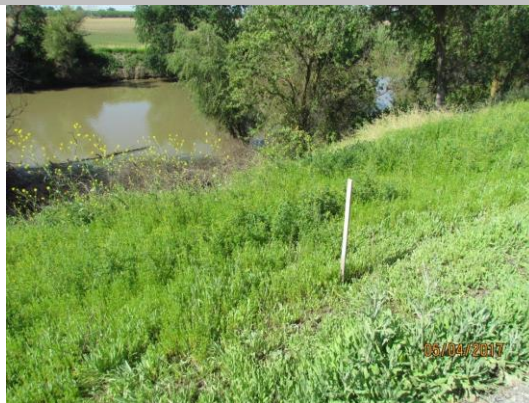
Photo 1 of 1 : SP_2018_RD0787_212_9_20180306_00007.jpg

LM Start	0.73	Rating **	A/W	Issue No.	9
LM End	0.73	Issue Type +	Ma	Location *	WS
Category	Earthen Levee			GPS Latitude/Longitude	
				Start	End
Item	Slope Stability			38.795814 °	38.795814 °
				-121.736799 °	-121.736799 °
DWR ID	DWR_RD0787_01_s_2017_9				
Comment Code					
S1 : Repair slope instability.					
Inspector Comment					
Multipel cracks visibile on a 50' section of the waterside slope.

View of slope stability location on waterside slope. Spring 2017.

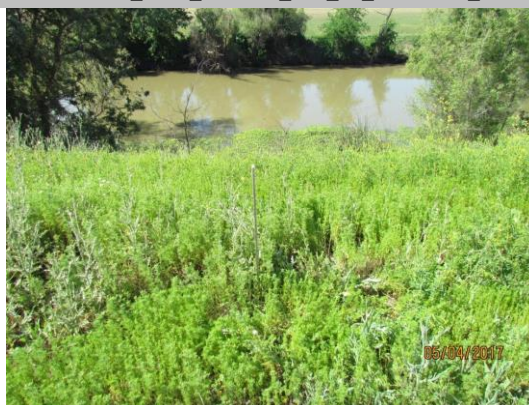
Photo 1 of 1 : SP_2018_RD0787_212_12_20180306_00009.jpg

LM Start	0.75	Rating **	A/W	Issue No.	12
LM End	0.75	Issue Type +	Ma	Location *	WS
Category	Earthen Levee			GPS Latitude/Longitude	
				Start	End
Item	Slope Stability			38.795891 °	38.795891 °
				-121.737098 °	-121.737098 °
DWR ID	DWR_RD0787_01_f_2017_12				
Comment Code					
S1 : Repair slope instability.					
Inspector Comment					
50' crack beginning to develop on wateride slope. Recommend monitoring.

View of slope stability location on waterside slope. Spring 2017.

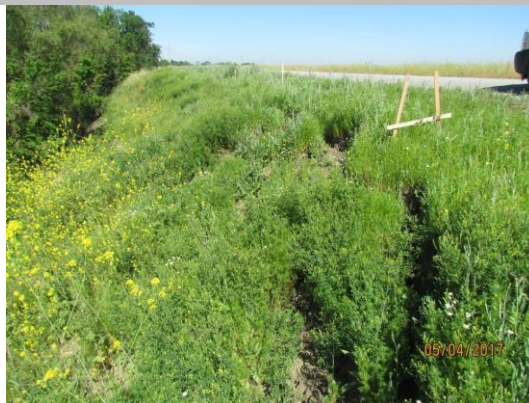
Photo 1 of 1 : SP_2018_RD0787_212_15_20180306_00016.jpg

LM Start	0.77	Rating **	A/W	Issue No.	15
LM End	0.77	Issue Type +	Ma	Location *	WS
Category	Earthen Levee			GPS Latitude/Longitude	
				Start	End
Item	Slope Stability			38.795996 °	38.795996 °
				-121.737493 °	-121.737493 °
DWR ID	DWR_RD0787_01_s_2017_15				
Comment Code					
S1 : Repair slope instability.					
Inspector Comment					
50' slough section on waterside slope.

View of sloughing on waterside slope. Spring 2017.

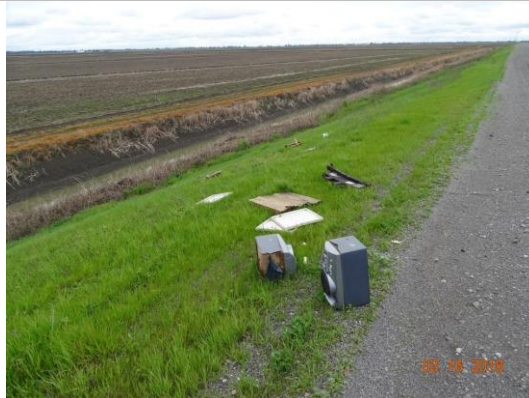
Photo 1 of 1 : SP_2018_RD0787_212_17_20180316_00022.jpg

LM Start	3.37	Rating **	M	Issue No.	17
LM End	3.37	Issue Type +	Ma	Location *	LS
Category	Earthen Levee			GPS Latitude/Longitude	
				Start	End
Item	Encroachments			38.814743 °	38.814743 °
				-121.778789 °	-121.778789 °
DWR ID	DWR_RD0787_01_s_2018_17				
Comment Code					
GA : Garbage					
Inspector Comment					
Speakers on landside slope.

View of speakers on the landside slope. Spring 2018.
